# Manhole Inspection Summary

Manhole # S19KK\_015MH

Insp Date: **6/5/07 7:32 AM**

**Location** Address: **2030 CLIFTON AVE**

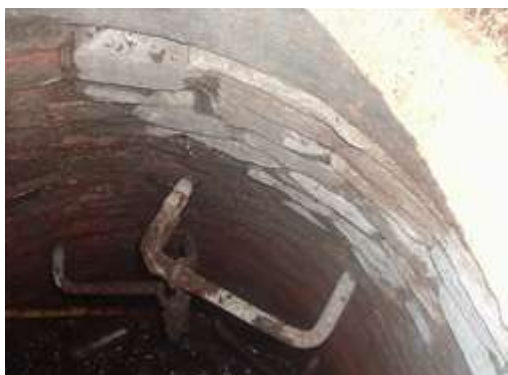
Defect 3

**Frame** Offset: **1** (in.) Condition: ☒ Sound ☐ Cracked ☐ Leaks

FRAME OFFSET

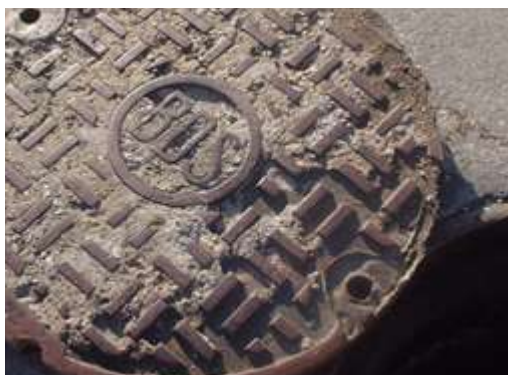
Defect 2

FRAME OFFSET

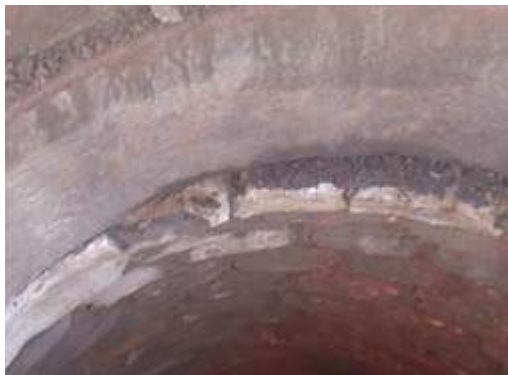
### Defect 4

Infiltration: ☐ None ☐ Joint ☐ Cracks ☐ Mortar ☐ Roots ☒ **Wall**

CORBEL WALL INFILTRATION

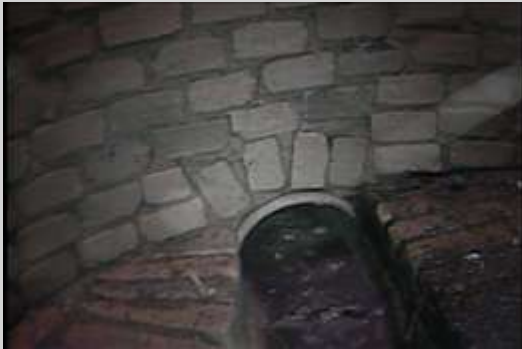
12 O'Clock Outflow

8 in. Circular Gravity Sewer  
Pipe Out @ 12 O'Clock

Pipe Height: **7.2** (in.) Rod and Bar (Angled)  
Pipe Material: **Clay** ☐ Pipe Lined  
Invert Depth: **9.66** (ft.) Flow Characteristics: **Slow**  
Deposits: ☐ None ☐ Mud ☐ Sludge ☒ **Debris** ☐ Grease  
Silt Depth: **3** (in.) Deposits Extent: **Light**  
Infiltration: **None** Pipe Seal Cond: **Sound**

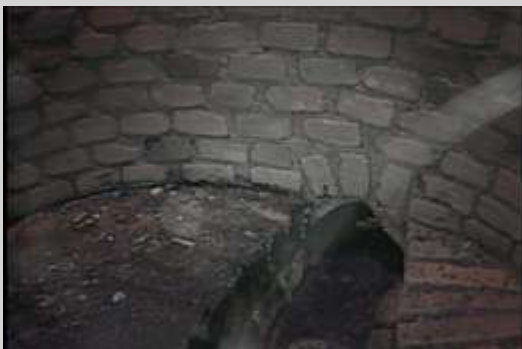
9 O'Clock Inflow

8 in. Circular Gravity Sewer  
Pipe In @ 9 O'Clock

Pipe Height: **7.2** (in.) Rod and Bar (Angled)  
Pipe Material: **Clay** ☐ Pipe Lined  
Invert Depth: **9.54** (ft.) Flow Characteristics: **Slow**  
Deposits: ☐ None ☐ Mud ☐ Sludge ☒ **Debris** ☐ Grease  
Silt Depth: **2** (in.) Deposits Extent: **Light**  
Infiltration: **None** Pipe Seal Cond: **Broken**
